**Flood Control Project Maintenance
Levee Inspections**

Fall 2013 Levee Maintenance Deficiency Summary Report

Sacramento River Basin

Sutter Maintenance Yard Maintenance Area 0005

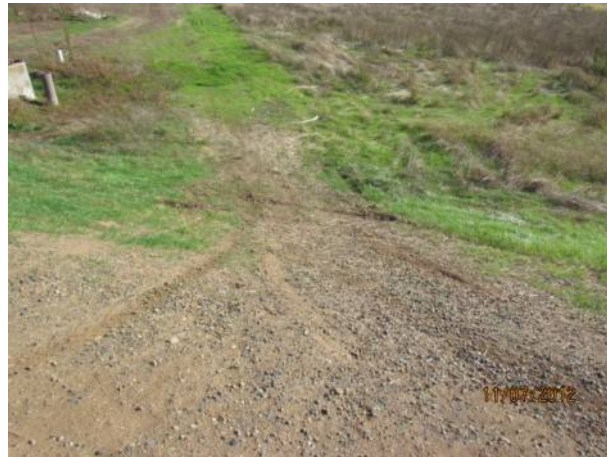
Levee Mile Report Line	8
Start Levee Mile	2.58
End Levee Mile	2.58
Location	Land Side
Category	Earthen Levee
Item	Slope Stability

View of the vehicle erosion along the landside slope.

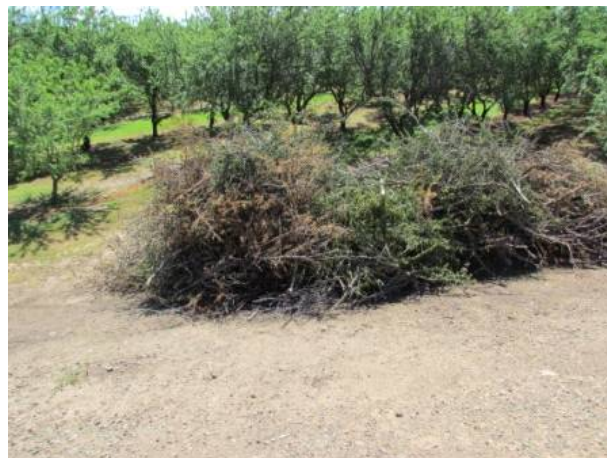
Levee Mile Report Line	9
Start Levee Mile	2.86
End Levee Mile	2.86
Location	Land Side
Category	Earthen Levee
Item	Encroachments

View of the large prunings pile along the L/S toe.

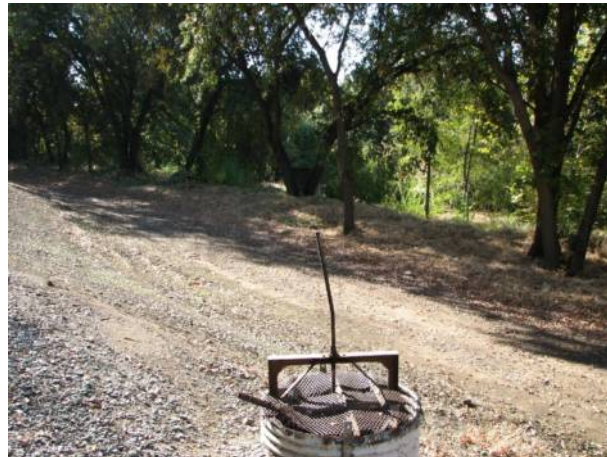
Levee Mile Report Line	12
Start Levee Mile	3.67
End Levee Mile	3.67
Location	Land Side
Category	Supplemental
Item	DWR UCIP Field Study

LMR No.	Levee Mile		Category	Item	Location	Rating	Action/Comment	GPS Latitude/Longitude		Issue No.
	Start	End						Start	End	
12	3.67	3.67	Supplemental	DWR UCIP Field Study	LS	M En	Inspector Comments: FS_ID:14058 EP_NO: N/A Repair Type: Non-Urgent Crossing Status: Found UCIP Comments: Pipe appears to be abandoned. Slide gate open and inoperable. Pipe should be properly abandoned.5/29/2013 Same as last inspection. FIELD_STRUCT_DESC: 30-inch corrugated metal siphon through levee, 10.5 feet below crown. Slide gate in corrugated metal riser on waterward slope. Concrete distribution box on LS toe and concrete overflow and siphon box at edge of berm. (USCE 1958) FS Date: 5/29/2013 1:54:14 PM	39.649522 ° -121.787965 °	39.649522 ° -121.787965 °	4 Y
DWR ID: DWR_MA0005_01_f_2013_4										
13	3.67	3.67	Supplemental	DWR UCIP Field Study	LS	M En	Inspector Comments: FS_ID:7521 EP_NO: N/A Repair Type: Non-Urgent Crossing Status: Found UCIP Comments: Pipe appears to be abandoned. Slide gate open and inoperable. Pipe should be properly abandoned. FIELD_STRUCT_DESC: 30-inch corrugated metal siphon through levee, 10.5 feet below crown. Slide gate in corrugated metal riser on waterward slope. Concrete distribution box on LS toe and concrete overflow and siphon box at edge of berm. (USCE 1958) FS Date: 10/30/2012	39.649522 ° -121.787965 °	39.649522 ° -121.787965 °	18

CMP riser with slide gate on WS shoulder.
Notice bent screw in open position.

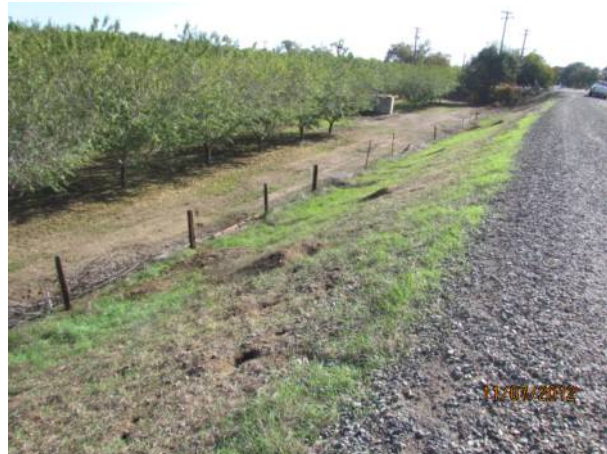
Levee Mile Report Line	14
Start Levee Mile	3.91
End Levee Mile	3.91
Location	Land Side
Category	Earthen Levee
Item	Animal Control

DWR ID: DWR_MA0005_01_f_2013_18										
14	3.91	3.91	Earthen Levee	Animal Control	LS	M Ma	A3 : No rodents visible, but rodent burrows visible; need to backfill and compact or grout burrows.	39.646599 ° -121.785705 °	39.646599 ° -121.785705 °	14 Y
DWR ID: DWR_MA0005_01_f_2012_14										
15	3.94	3.94	Earthen Levee	Slope Stability	LS	C Ma	S3 : Repair the levee slope damaged by vehicle traffic and prevent access where possible.	39.646133 ° -121.785370 °	39.646133 ° -121.785370 °	15
DWR ID: DWR_MA0005_01_f_2013_15										
16	3.97	3.97	Supplemental	DWR UCIP Field Study	LS	U En	Inspector Comments: FS_ID:14061 EP_NO: 6544A Repair Type: Urgent Crossing Status: Indicator Found UCIP Comments: Pipeline should be marked where pipe crosses levee as it is 4-feet below the surface.5/29/2013 Same as last inspection. FIELD_STRUCT_DESC: 6-inch concrete encased high pressure steel gas line through the levee, 4.0 feet below the crown. 8-inch diameter PG&E gas access manhole located on south side of road 250-feet east of levee crown. (Permit No. 6544A) FS Date: 5/29/2013 1:56:01 PM	39.645846 ° -121.785155 °	39.645846 ° -121.785155 °	19 Y

View of the rodent activity along the landside slope.

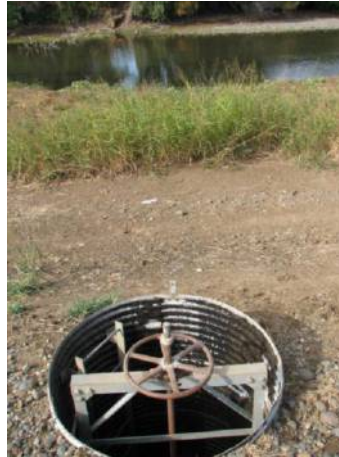
Levee Mile Report Line	18
Start Levee Mile	5.65
End Levee Mile	5.65
Location	Land Side
Category	Supplemental
Item	DWR UCIP Field Study

LMR No.	Levee Mile		Category	Item	Location	Rating	Action/Comment	GPS Latitude/Longitude		Issue No.
	Start	End						Start	End	
20	5.65	5.65	Supplemental	DWR UCIP Field Study	LS	M En	Inspector Comments: FS_ID:7529 EP_NO: N/A Repair Type: Non-Urgent Crossing Status: Found UCIP Comments: Pipe 1/2 filled with soil at slide gate end. FIELD_STRUCT_DESC: 1 of 2. 36-inch pipe through levee 11.0 feet below crown. Slide gate in 54-inch corrugated metal riser on waterward slope and concrete "U" headwall on the landward side. (USACE 1957) FS Date: 10/30/2012	39.624559 ° -121.772141 °	39.624559 ° -121.772141 °	23
DWR ID: DWR_MA0005_01_f_2013_23										
21	5.65	5.65	Supplemental	DWR UCIP Field Study	LS	M En	Inspector Comments: FS_ID:7528 EP_NO: N/A Repair Type: Non-Urgent Crossing Status: Found UCIP Comments: Pipe 1/2 filled with soil at slide gate on WS. FIELD_STRUCT_DESC: 2 of 2. 36-inch pipe through levee 11.0 feet below crown. Slide gate in 54-inch corrugated metal riser on waterward slope and concrete "U" headwall on the landward side. (USACE 1957) FS Date: 10/30/2012	39.624559 ° -121.772141 °	39.624559 ° -121.772141 °	24

54-inch CMP riser and slide gate on WS shoulder.

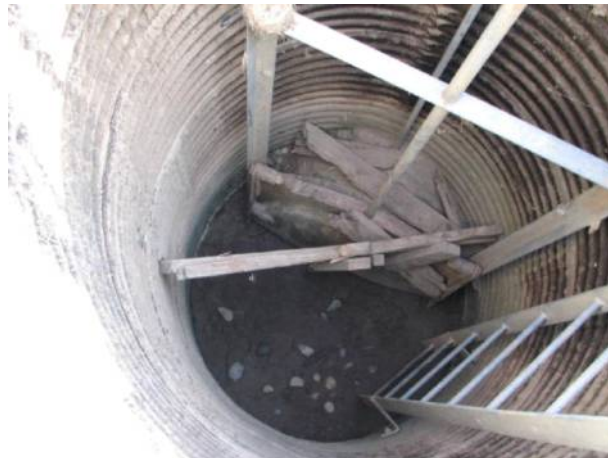
Levee Mile Report Line	19
Start Levee Mile	5.65
End Levee Mile	5.65
Location	Land Side
Category	Supplemental
Item	DWR UCIP Field Study

Slide gate at bottom of cmp riser.

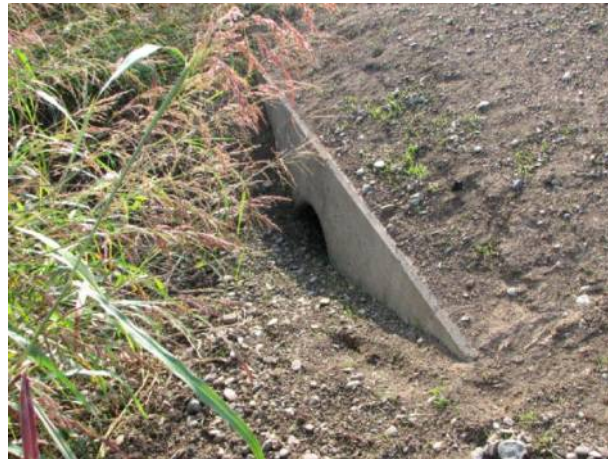
Levee Mile Report Line	24
Start Levee Mile	7.70
End Levee Mile	7.70
Location	Land Side
Category	Supplemental
Item	DWR UCIP Field Study

Headwall at LS toe.

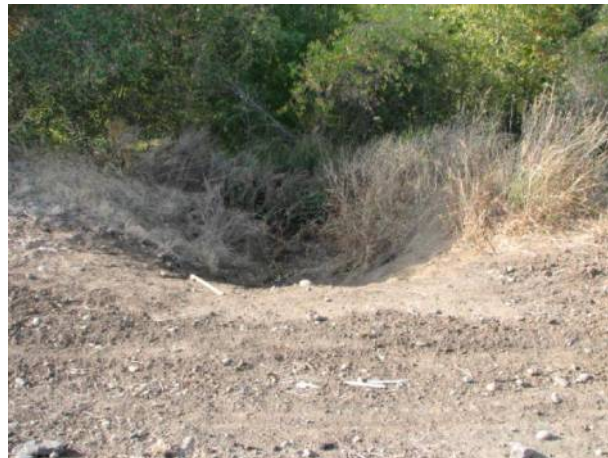
Levee Mile Report Line	25
Start Levee Mile	8.33
End Levee Mile	8.33
Location	Land Side
Category	Supplemental
Item	DWR UCIP Field Study

25	8.33	8.33	Supplemental	DWR UCIP Field Study	LS	M En	Inspector Comments: FS_ID:14081 EP_NO: N/A Repair Type: Non-Urgent Crossing Status: Found UCIP Comments: Pipe filled with soil.5/29/2013 Same as last inspection. FIELD_STRUCT_DESC: 24-inch corrugated metal pipe through the levee, 9.3 feet below the crown. Flap gate on the waterward end. Concrete headwall at both toes. (USACE 1952) FS Date: 5/29/2013 2:17:09 PM	39.589751 ° -121.792818 °	39.589751 ° -121.792818 °	27 Y
----	------	------	--------------	----------------------	----	---------	--	------------------------------	------------------------------	---------

Outlet at WS toe.

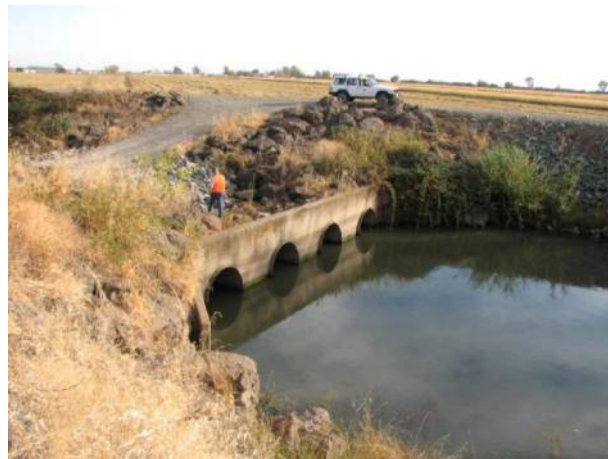
Levee Mile Report Line	30
Start Levee Mile	9.65
End Levee Mile	9.65
Location	Land Side
Category	Supplemental
Item	DWR UCIP Field Study

WS of pipe crossing

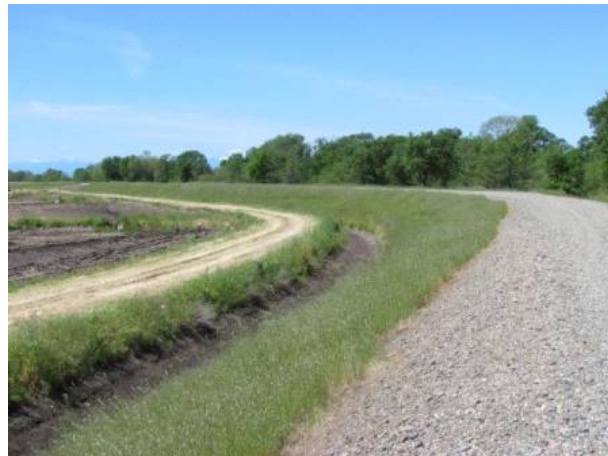
Levee Mile Report Line	37
Start Levee Mile	9.66
End Levee Mile	10.48
Location	Land Side
Category	Earthen Levee
Item	Encroachments

View of the AG ditch along the L/S toe.

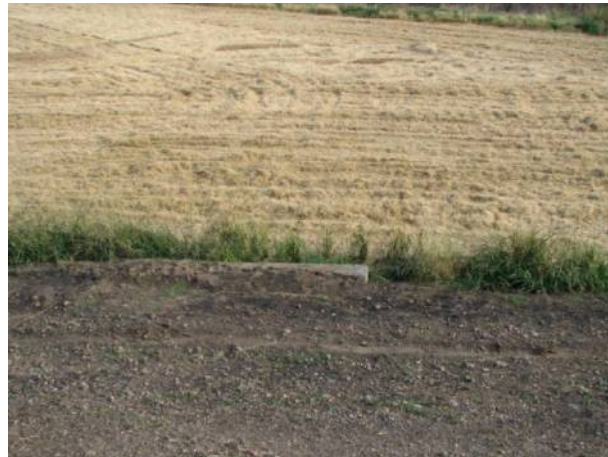
Levee Mile Report Line	41
Start Levee Mile	10.99
End Levee Mile	10.99
Location	Land Side
Category	Supplemental
Item	DWR UCIP Field Study

41	10.99	10.99	Supplemental	DWR UCIP Field Study	LS En	M	Inspector Comments: FS_ID:14088 EP_NO: N/A Repair Type: Non-Urgent Crossing Status: Found UCIP Comments: Pipe buried on both sides of levee. 5/29/2013 Same as last inspection. FIELD_STRUCT_DESC: 30-inch corrugated metal drainpipe through the levee, 12.2 feet below the crown. Flap gate on the waterward end. (USCE 1952) FS Date: 5/29/2013 2:23:13 PM	39.562559 ° -121.825808 °	39.562559 ° -121.825808 °	42 Y
DWR ID: DWR_MA0005_01_f_2013_42

Concrete headwall at LS toe.

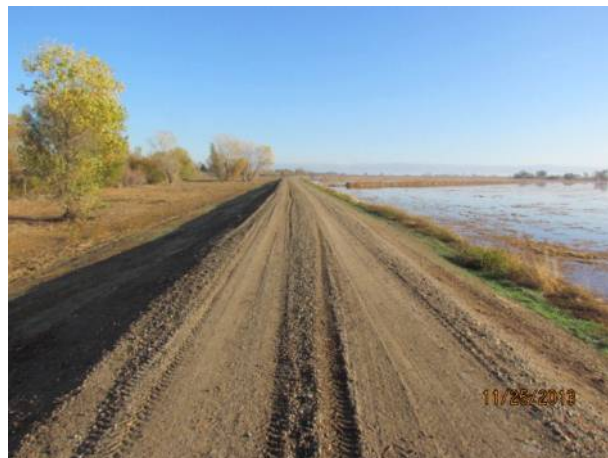
Levee Mile Report Line	45
Start Levee Mile	11.01
End Levee Mile	11.01
Location	Land Side
Category	Earthen Levee
Item	Vegetation

View of the both slopes that has been burned and dragged.

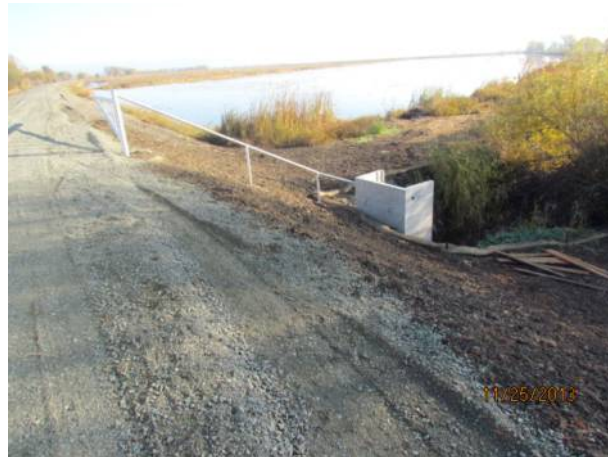
Levee Mile Report Line	48
Start Levee Mile	11.96
End Levee Mile	11.96
Location	Land Side
Category	Earthen Levee
Item	Encroachments

View of the new 24 inch pipe and riser.

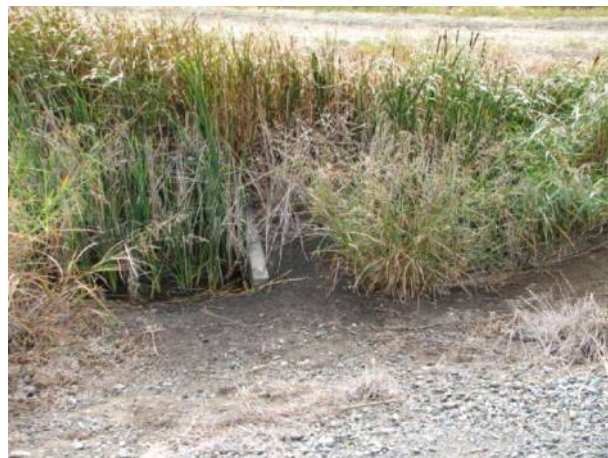
Levee Mile Report Line	51
Start Levee Mile	12.00
End Levee Mile	12.00
Location	Land Side
Category	Supplemental
Item	DWR UCIP Field Study

49	12.00	12.00	Supplemental	DWR UCIP Field Study	LS	M En	Inspector Comments: FS_ID:14098 EP_NO: N/A Repair Type: Non-Urgent Crossing Status: Indicator Found UCIP Comments: Pipe buried on both LS and WS. 5/29/2013 Same as last inspection. FIELD_STRUCT_DESC: 48" Corrugated Metal Pipe riser and sparring water meter/irrigation structure. 4-foot by 6-foot concrete outlet box on LS toe.(USACE 1952) FS Date: 5/29/2013 2:30:39 PM	39.551212 ° -121.837724 °	39.551212 ° -121.837724 °	48
DWR ID: DWR_MA0005_01_f_2013_48										
50	12.00	12.00	Supplemental	DWR UCIP Field Study	LS	M En	Inspector Comments: FS_ID:7673 EP_NO: N/A Repair Type: Non-Urgent Crossing Status: Indicator Found UCIP Comments: Pipe buried on both LS and WS. FIELD_STRUCT_DESC: 48" Corrugated Metal Pipe riser and sparring water meter/irrigation structure. 4-foot by 6-foot concrete outlet box on LS toe.(USACE 1952) FS Date: 10/31/2012	39.551212 ° -121.837724 °	39.551212 ° -121.837724 °	49

Buried pipe at concrete box, LS toe.

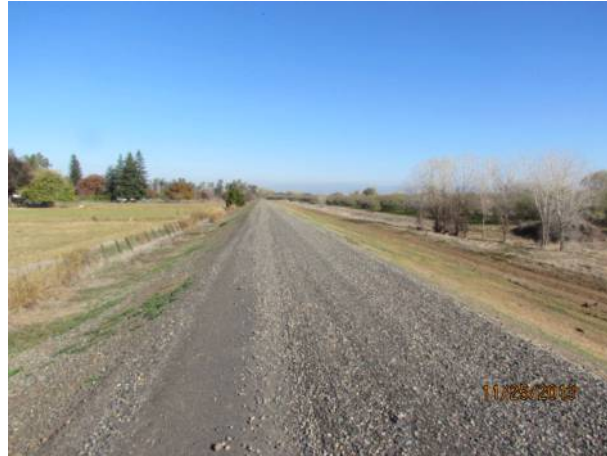
Levee Mile Report Line	29
Start Levee Mile	8.99
End Levee Mile	8.99
Location	Land Side
Category	Earthen Levee
Item	Vegetation
View of both slopes that has been burned and dragged.	
rduffey_f_20131126_200.JPG

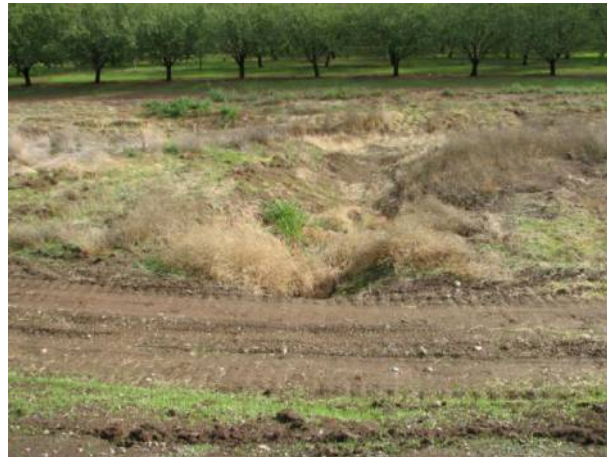
Levee Mile Report Line	30
Start Levee Mile	9.59
End Levee Mile	9.59
Location	Land Side
Category	Supplemental
Item	DWR UCIP Field Study
View of outlet looking toward WS toe.	
UCIP_3382.jpg

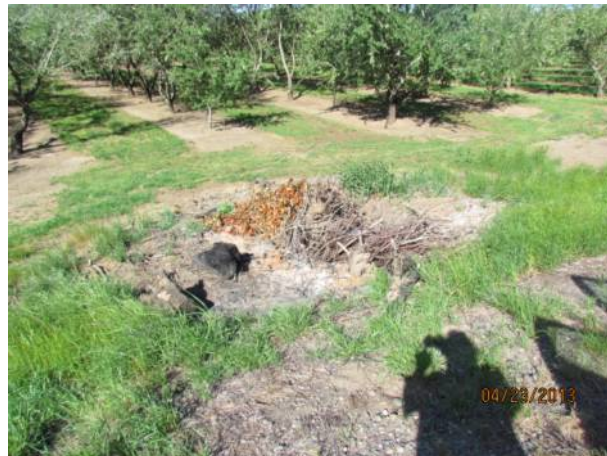
Levee Mile Report Line	33
Start Levee Mile	10.54
End Levee Mile	10.54
Location	Land Side
Category	Earthen Levee
Item	Encroachments
View of the prunings along the landside toe.	
rduffey_f_20130919_775.JPG

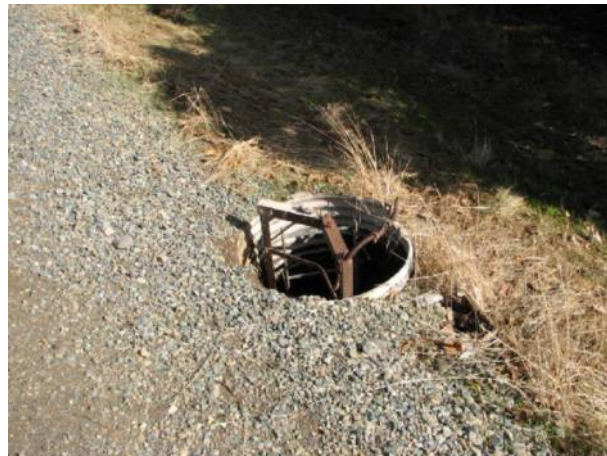
Levee Mile Report Line	47
Start Levee Mile	12.99
End Levee Mile	12.99
Location	Land Side
Category	Supplemental
Item	DWR UCIP Field Study

Broken slide gate in CM riser on WS slope.

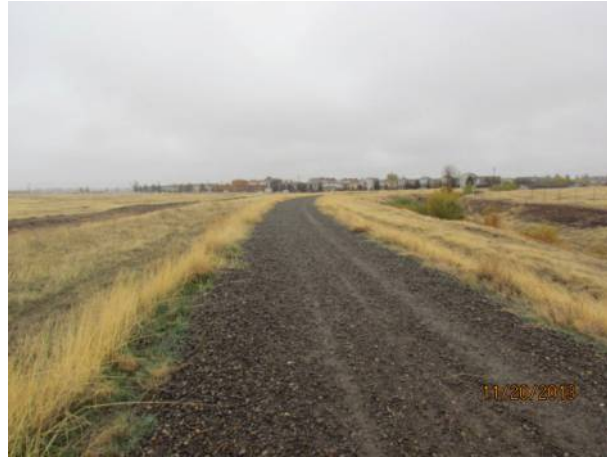
Levee Mile Report Line	1
Start Levee Mile	0.53
End Levee Mile	0.53
Location	Land Side
Category	Earthen Levee
Item	Vegetation
View of both slopes that has been mowed.	
rduffey_f_20131126_202.JPG
